TECHNICAL REPORT D-86-2

THE DUWAMISH WATERWAY CAPPING DEMONSTRATION PROJECT: ENGINEERING ANALYSIS AND RESULTS OF PHYSICAL MONITORING

Clifford L. Truitt

Environmental Laboratory

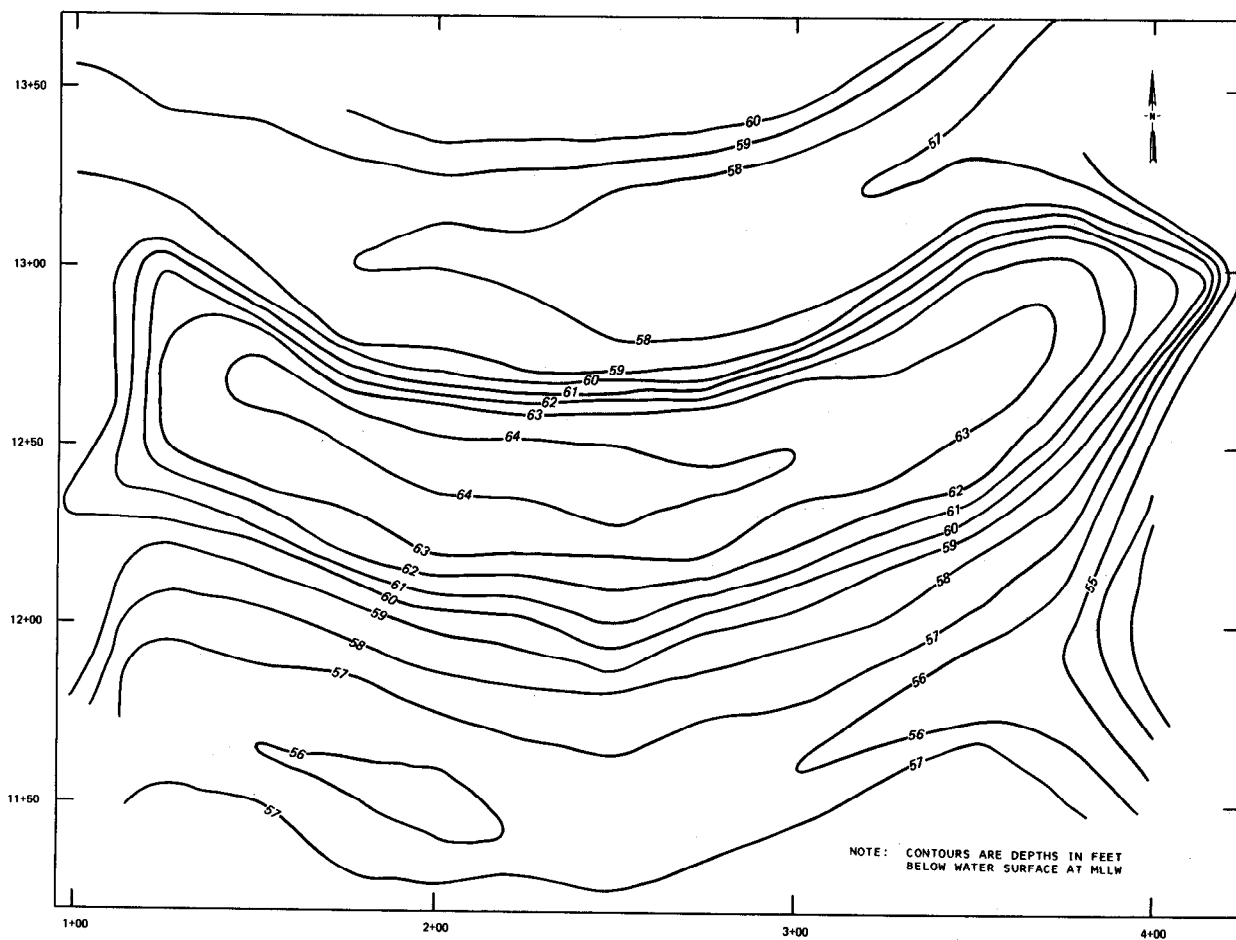
Figure 2. Bathymetry at disposal site

7. The depressions are a series of fairly regular, wavelike forms reported to be the result of previous private dredging operations. The depressions are oriented perpendicular to the long axis of the waterway, measure typically 100 ft across, and are from 6 to 10 ft below surrounding elevations. Bathymetry of the depression selected for the disposal site is shown in Figure 2. The contours shown were constructed from soundings provided by the NPS and are referenced to the MLLW datum. The tidal range in the Seattle area is just over 11 ft, so the maximum depth at the disposal site could vary from 64 to 75 ft during a normal tidal cycle. Nominal dimensions of the target site were 100 to 150 ft wide by 300 ft long. The site is approximately 4,000 ft up the waterway from its opening into Elliott Bay. Bulkheads line both sides of the reach and the total width of the waterway in the area is 750 ft. Figure 3 is a general view in the vicinity of the disposal site.

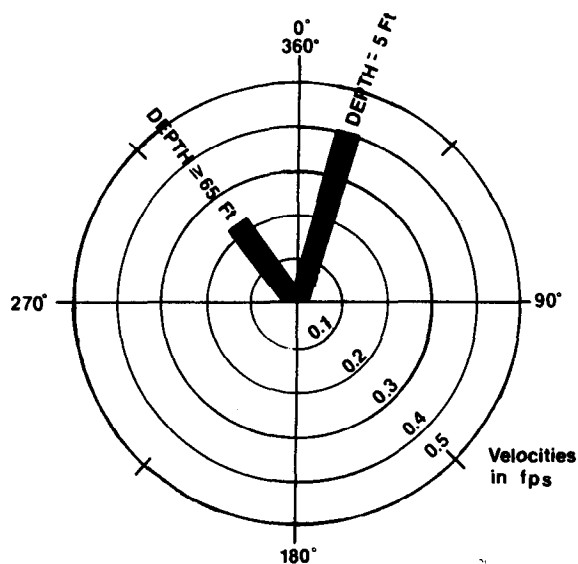
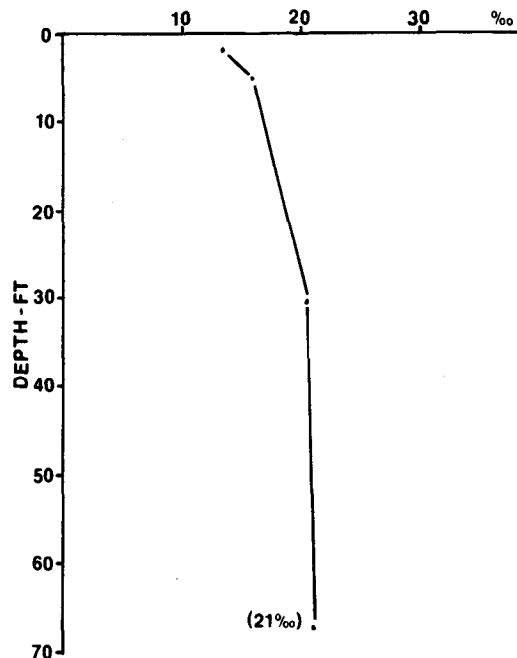
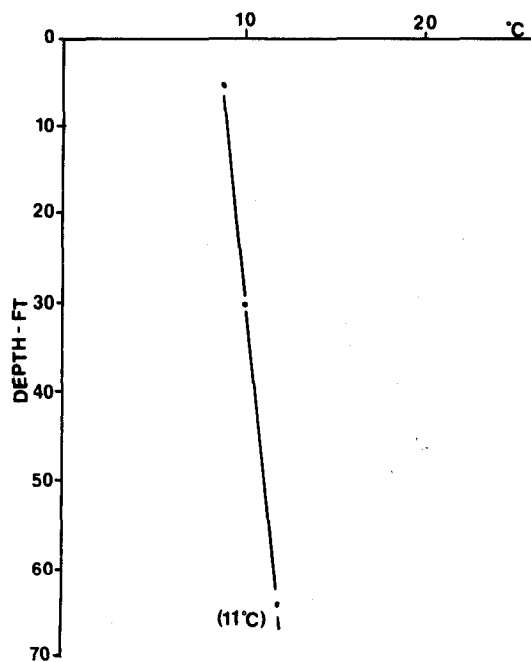
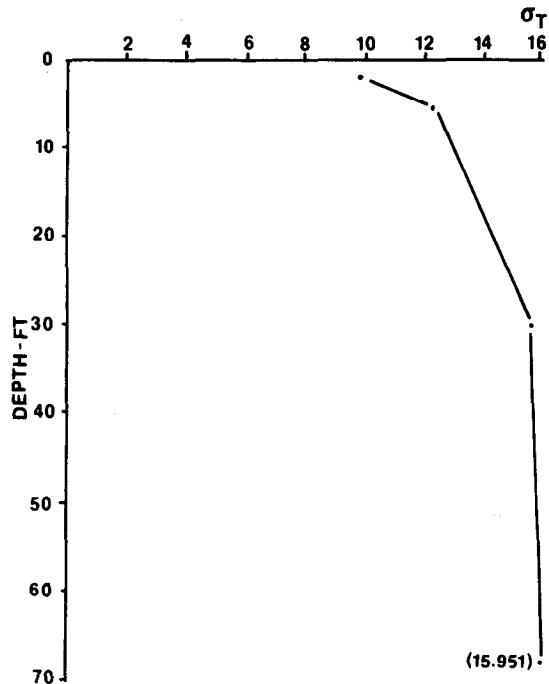
CURRENT SPEED AND DIRECTION

NOTE: Channel axis runs approximately north-south. 0°/360° is north.

Figure 4. Physical parameters measured at disposal site

10. The highest current velocity measured during the fieldwork was a single value of 1.4 fps just beneath the water surface. Sustained maximum values in the upper third of the water column were more typically 0.4 to 0.8 fps. Sustained maximum values near the bottom were approximately 0.2 fps. The recording current meters showed frequent periods during which current velocities were less than the instrument threshold value of approximately 0.05 fps. Figure 4 presents a current rose representative of site conditions at the actual time of the disposal.

11. Ambient salinity, temperature, and density data are also presented on Figure 4. Bulk samples of the water at both the dredge site and the disposal site were obtained two days prior to the start of dredging for analysis of background chemical constituents and for use in elutriate tests. Results of these chemical analyses are shown in Table 1 as background values.

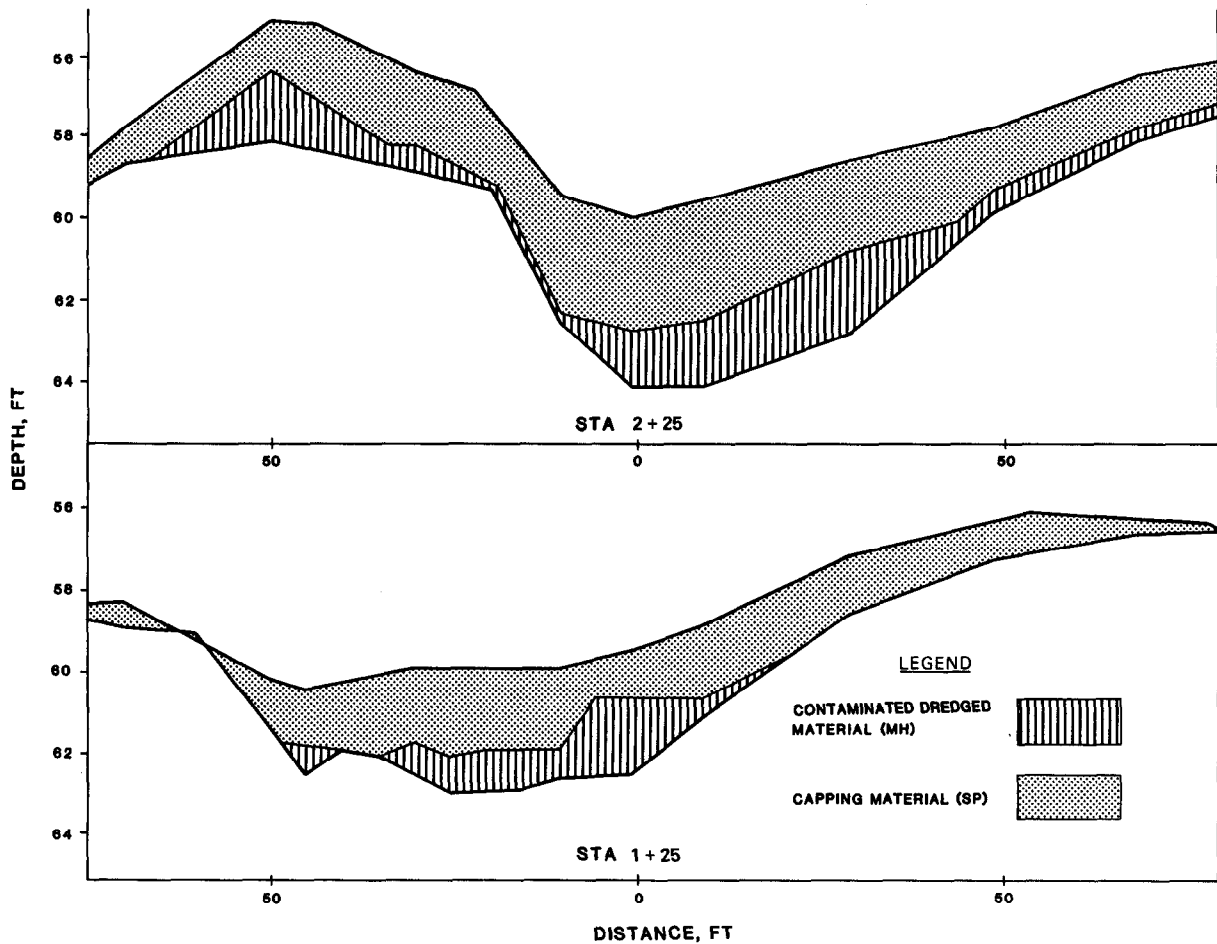
Figure 5. Typical composite profiles through completed disposal mound

26. The profiles indicate that the dumping phase of the disposal was generally successful in accurately placing the contaminated sediment into the selected depression. The material descended to the bottom as a relatively cohesive mass and struck the targeted portion of the site with little or no deflection by currents. However, some profiles (e.g. Figure 5) show areas in which a volume of sediment has been deposited on the waterway bottom outside the depression. Two explanations seem plausible. Either the force of the impact was such that a portion of the contaminated material surged up the side slope (3-4 ft) and came to rest on the bottom adjacent to the depression; or, the impact displaced a volume of soft, surface sediment originally lining the depression. Analysis of cores subsequently concentrated in this area should establish which process occurred.

27. The profiles were used to produce contour overlays of the original bathymetry showing the thickness of the contaminated material across the site immediately following disposal (Figure 6). As shown, the center of mass of the placed material is clearly within the confines of the disposal depression. The deposited material was just over 3 ft thick at its thickest point. The symmetry of the thickness contours and the steepness of the slopes within the material as indicated in Figure 5 are likely due to the cohesive nature of the descending mass. Even the portion of the load (or bottom sediment) that surged out of the depression appeared to have detached itself as a well-defined mass that came to rest intact rather than flowing in a dispersive, radial pattern.

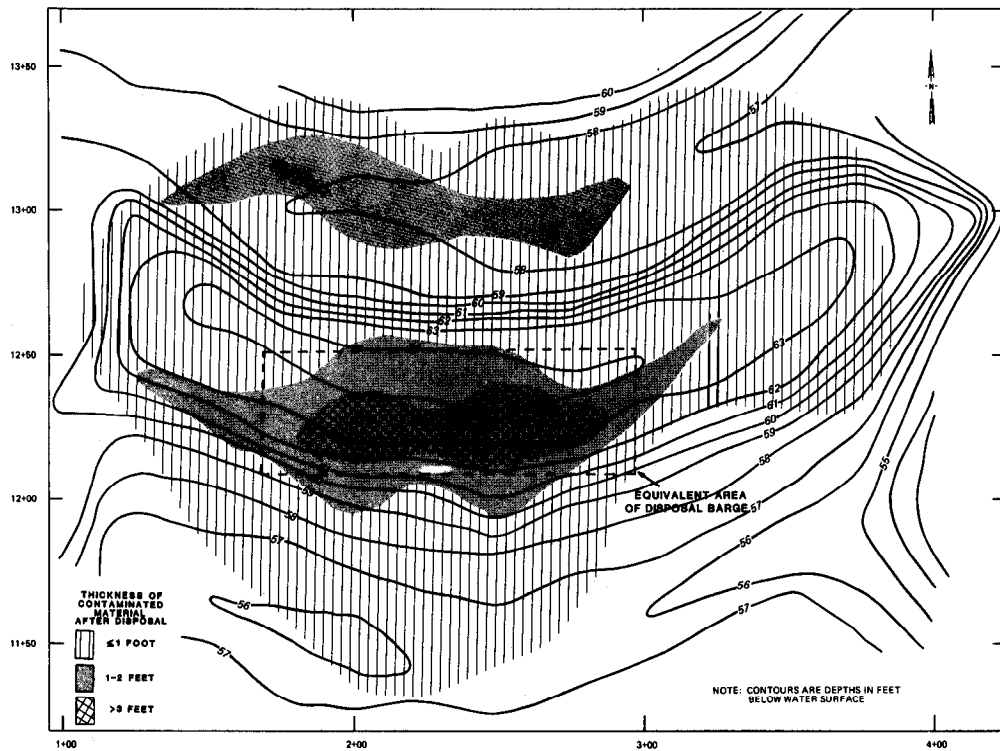
Figure 6. Contours of the thickness of contaminated material in the disposal mound

28. The dimensions of the hopper in the barge from which the disposal was made were 128 ft long by 40 ft wide (Sumeri 1984). From Figure 6 it can be seen that almost 40 percent of the total volume remained on the bottom in an equivalent size area, never leaving the limits of the barge "footprint" during the exit, descent, and bottom collapse. A volume roughly equivalent to 20 to 25 percent of the original volume appears to be contained in the detached portion of the mound.

30. Figures 4-6 also indicate that even though the combined thickness of contaminated material and capping material approaches 7 ft at some points, the elevation of the completed site is at or below surrounding bottom elevations. Continued mound consolidation will further ensure that the disposal area remains essentially a concave feature with respect to adjacent bottom topography. While this is not considered a requirement for successful CAD design, it is felt to be a desirable condition where possible. Such a condition should reduce the effects of any currents present in the area. A highly depressed cap surface with abrupt side slopes could be counterproductive by inducing turbulence at the discontinuity.

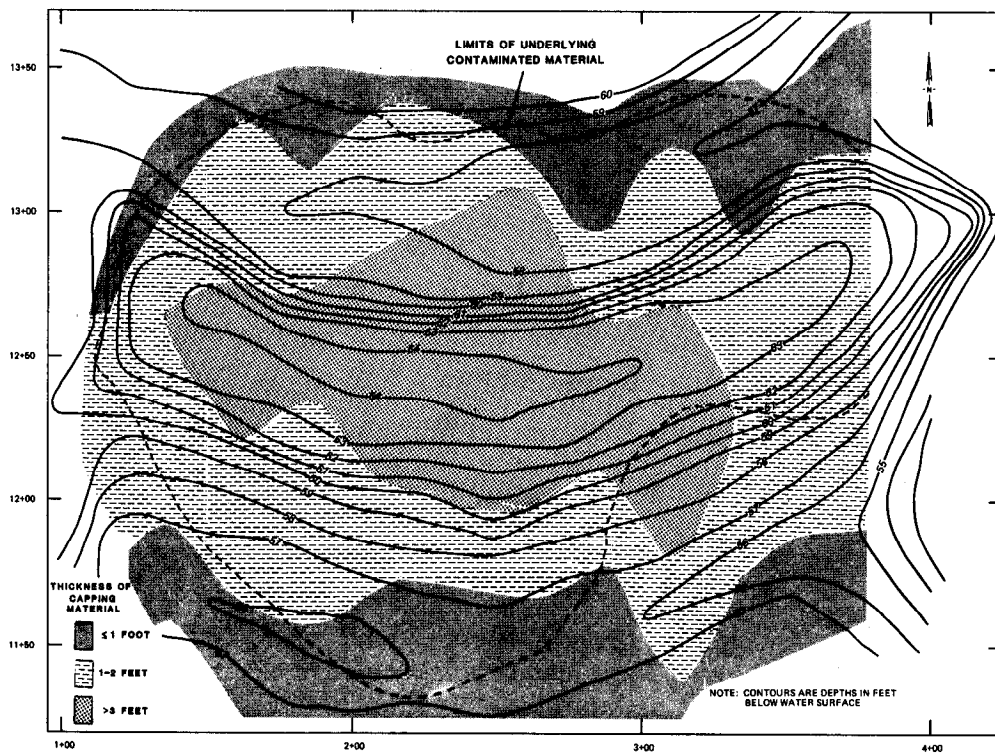
Figure 7. Thickness contours of the completed cap over the disposal mound

29. Similar procedures were used to sketch thickness contours of the completed cap as shown in Figure 7. The central area represents a cap thickness of at least 3 ft with the majority of the site having a cover of 1 to 2 ft of clean sand. The cap was placed in three successive,

parallel-positioned, overlapping operations. The pattern effects of the three different disposals can be seen in Figure 7. The desired overlay and uniformity of cap thickness over the entire site are clearly shown. The profiles produced after the contaminated material was placed show the portion of the material that had surged out of the depression and the coverage of this area achieved by the incremental capping technique.

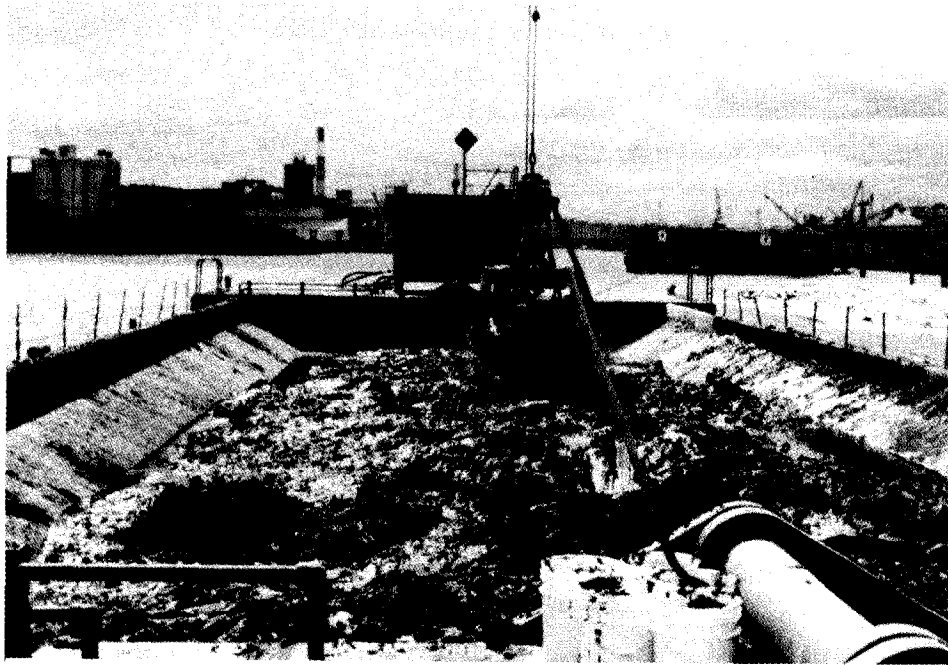
Figure 8. Clamshell loading barge during dredging operation

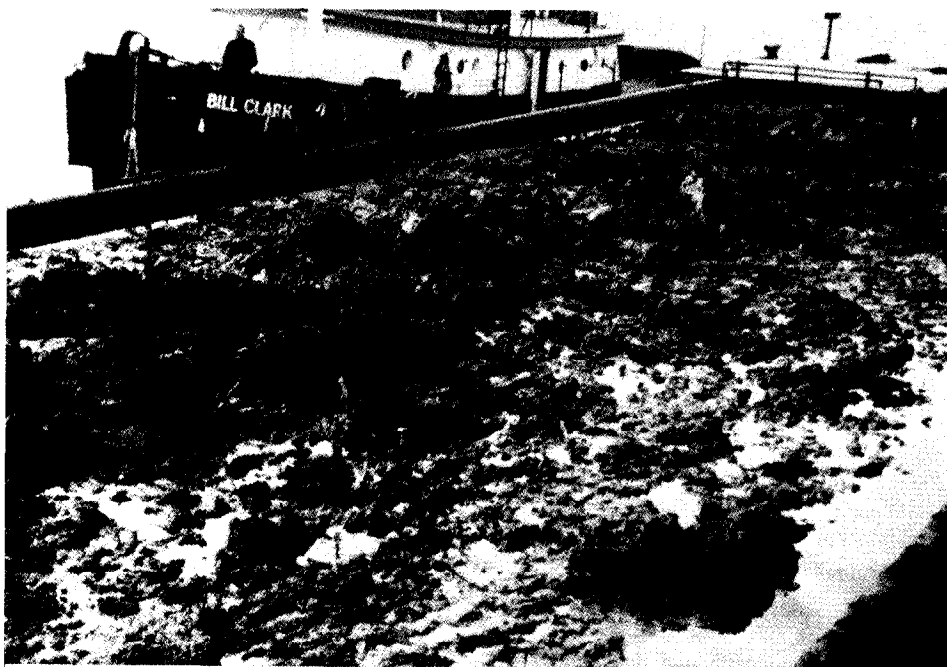
Figure 9. Contaminated material in barge prior to disposal

39. Samples of the same material were taken directly from the disposal barge the day after dredging was completed and subsequently analyzed at WES. The average bulk density (wet) of the material in the barge was 1,464 g/l compared with the average density in the shoal of 1,425 g/l. Since no solids were gained, the apparent increase in density must have been due to a decrease in void ratio and a reduction in the moisture content from consolidation and

drainage in the barge. In fact, the moisture content of material in the barge prior to disposal was measured to be 99 percent. The void ratio was then calculated to be 2.6, confirming the reduction indicated. It should be noted that some free water was observed on the surface of the material in the barge. This was evidently water added by the bucket during dredging and the small actual amount freed during the change in void ratio. It appears that any water added by the bucket dredging process did not readily find its way into the pore space of this soil and is an addition only in the sense of bulk volume. At the time of disposal the material was in a similar or slightly denser state with greater internal strength than it was in situ. Figures 8 and 9 show the dredge placing material in the barge and the surface of the material in the barge after loading had been completed.

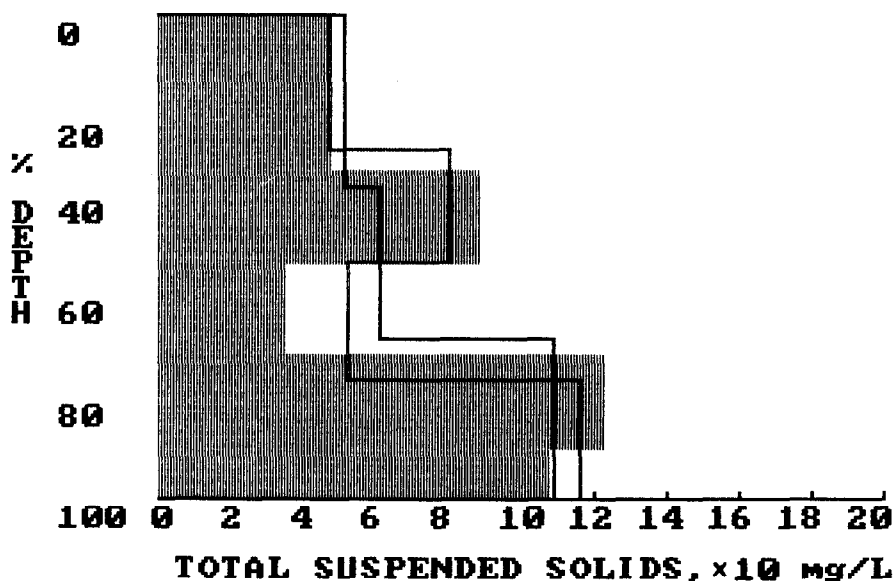
Figure 10. Typical representation of total suspended solids from single sampling event

first level of refinement to such calculations. In this approach the values of suspended solids concentration measured from discrete samples taken at varying depths are assigned or averaged over only an increment of depth at which they were taken. This replaces a single depth-averaged value with a series of concentrations associated with a number of "slices" through the water column. Further, as shown in Figure 10, the depth scale itself is normalized by the total water depth at the station in order to present the values as an incremental percentage of depth. This allows comparison of relative concentrations at stations with different water depths.

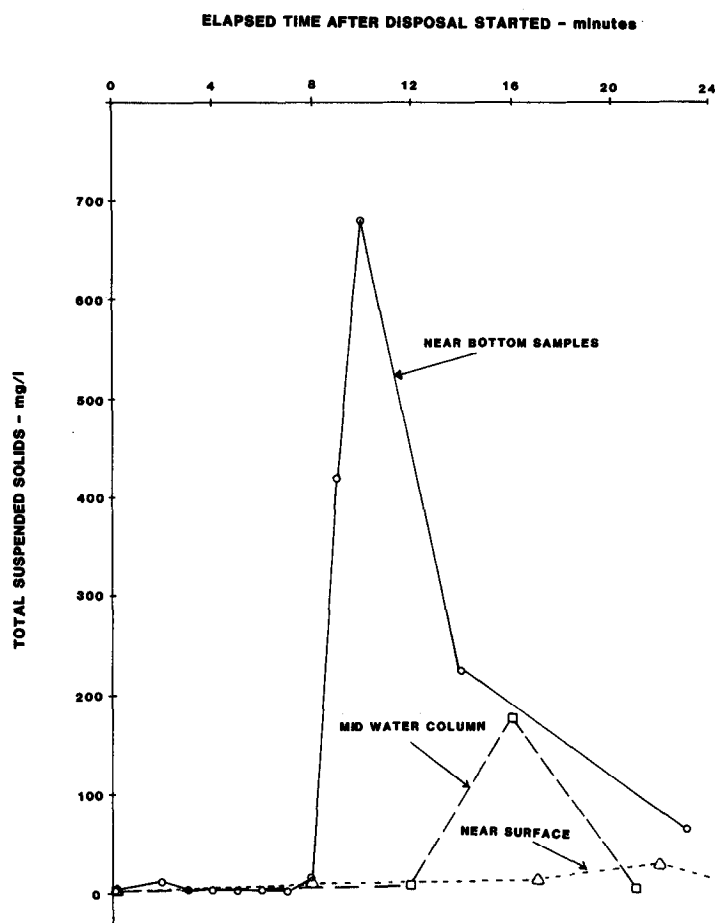
Figure 11. Time series of total suspended solids at typical station following disposal

47. In contrast to the dredging operation itself, the actual disposal was a short-term event. The variation of solids concentration with time during that period is an important factor. Figure 11 is a plot of total suspended solids versus time after disposal at a representative station approximately 400 ft downcurrent from the disposal site. The three different curves represent samples taken near surface, mid water column, and near bottom. Background levels of solids at the time were measured as typically 5 mg/l or less and the values shown in the figure have not been adjusted. The relatively rapid passage of a very distinct solids plume can clearly be seen.

indicate that the concentration of solids in the mid and upper water column did not increase above typical background levels. A peaked distribution similar to that shown in Figure 11 was observed at the near-bottom sample series. This supports the assumption that advective processes, e.g. currents and momentum driven flow, were the principal sources of transport within the limits of the disposal site itself.

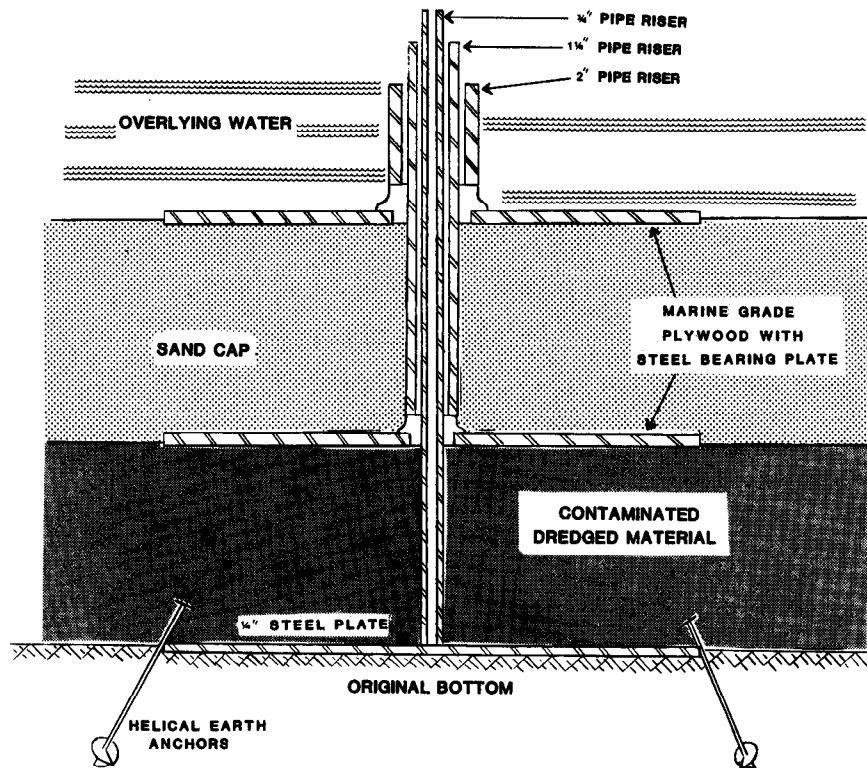
Figure 12. Schematic of tiered settlement plates

55. Settlement plates were placed at the site prior to disposal operations to facilitate monitoring of consolidation in the materials over time. These plates were of tiered design so that changes in each of the materials could be evaluated independently. A telescoping arrangement permitted placement of the lower plates on the foundation soil prior to disposal, the second tier on the surface of the dredged material, and the third tier of plates on the surface of the cap (Figures 12 and 13). Plates were installed by divers and initial readings of exposed riser lengths were noted. The lowest level of plates was anchored to the bottom using helical earth anchors. In spite of this anchoring arrangement, the impact of the dredged material on the bottom after disposal was so violent that several of the plates were overturned and lost. The presence of 1 to 2.5 ft of very soft organic silts (ML, MH) overlying more sandy foundation materials is believed to be a major factor in the instability of the settlement plates. Readings of the remaining usable tiers were made after each phase of the disposal, after approximately 1 week, and after 6 months. Analysis of the data is continuing, but readings indicate that the original 24- to 36-in. thickness of deposited dredged material has consolidated to 21 to 33 in. in the 6-month interval. The consolidation progressed rapidly with approximately 75 percent of the total settlement to date occurring in the first week after placement. Little change has been noted in the thickness of the sand cap.

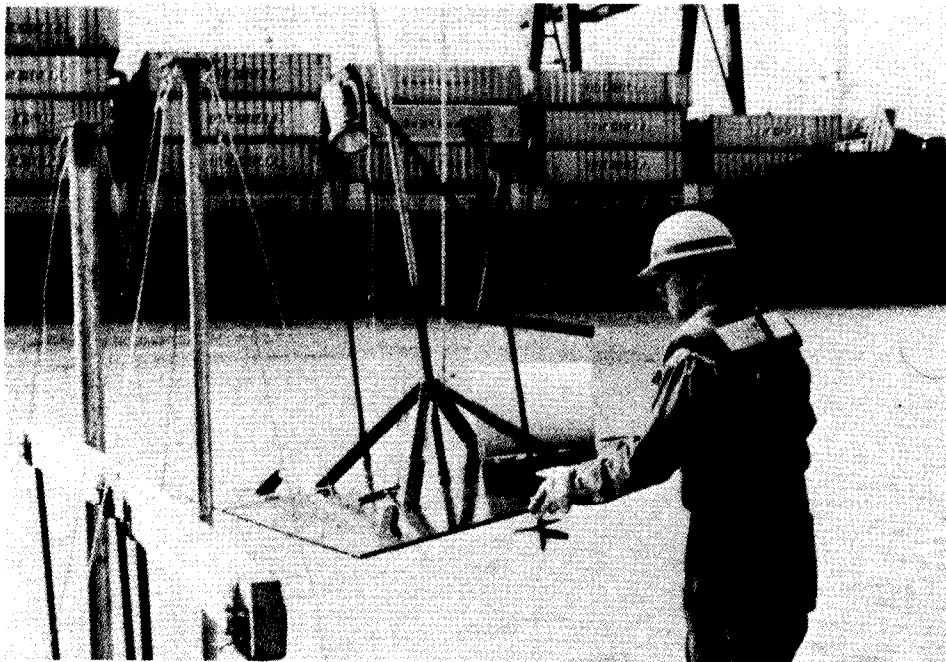
Figure 13. View of settlement plates prior to placement

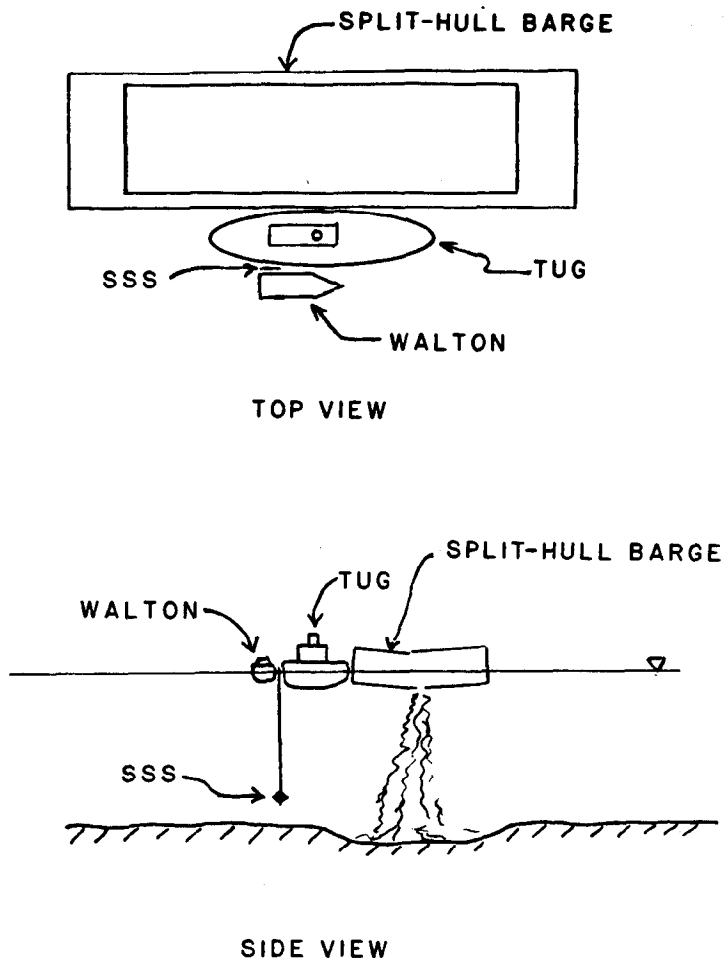
Figure 14. SSS positioning during dredged material disposal

premeasured ropes 36 ft below the surface. The 500-kHz "fish" was used. It was set on the 50-m range, and paper speed was 50 lines/cm. The WALTON was tied to a tug positioned parallel to the barge at its midpoint (Figure 14). The addition of the 20-ft beam of the tug caused the SSS "fish" to be 45 ft from the centerline of the barge.

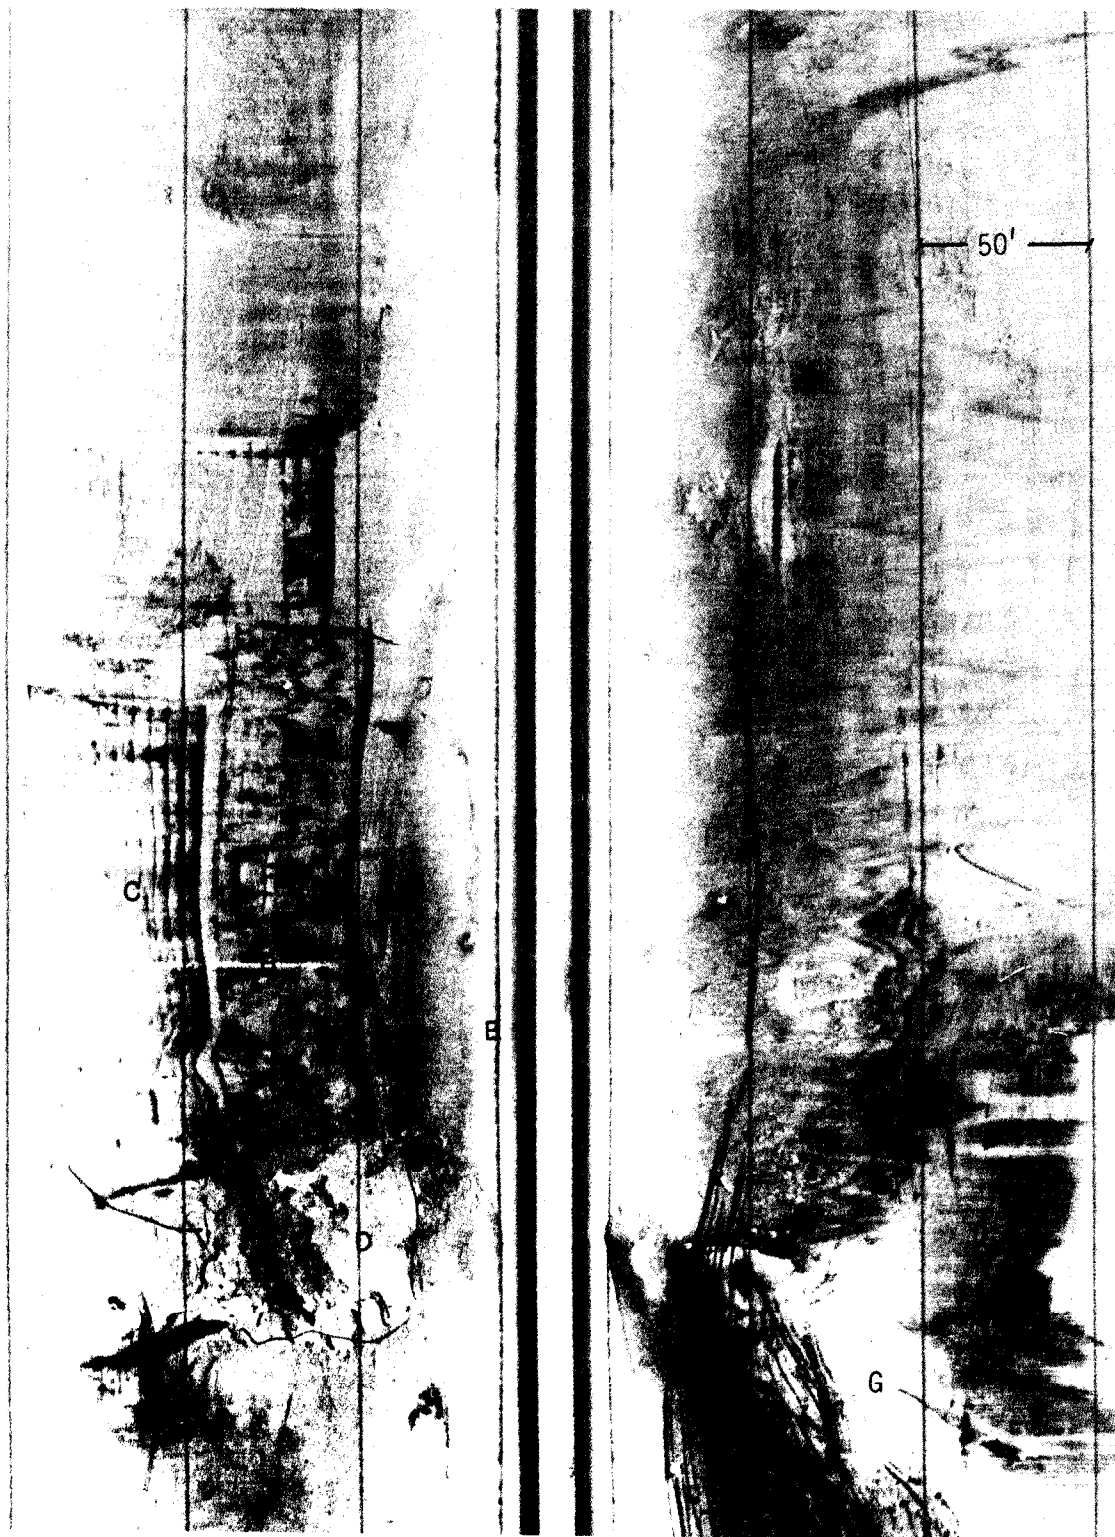
Figure 15. SSS image of contaminated sediment dredging.
 A = dredge, B = dredge's spud, C = barge, D = dredged area,
 E = dredge plume, F = dark area, and G = log boom

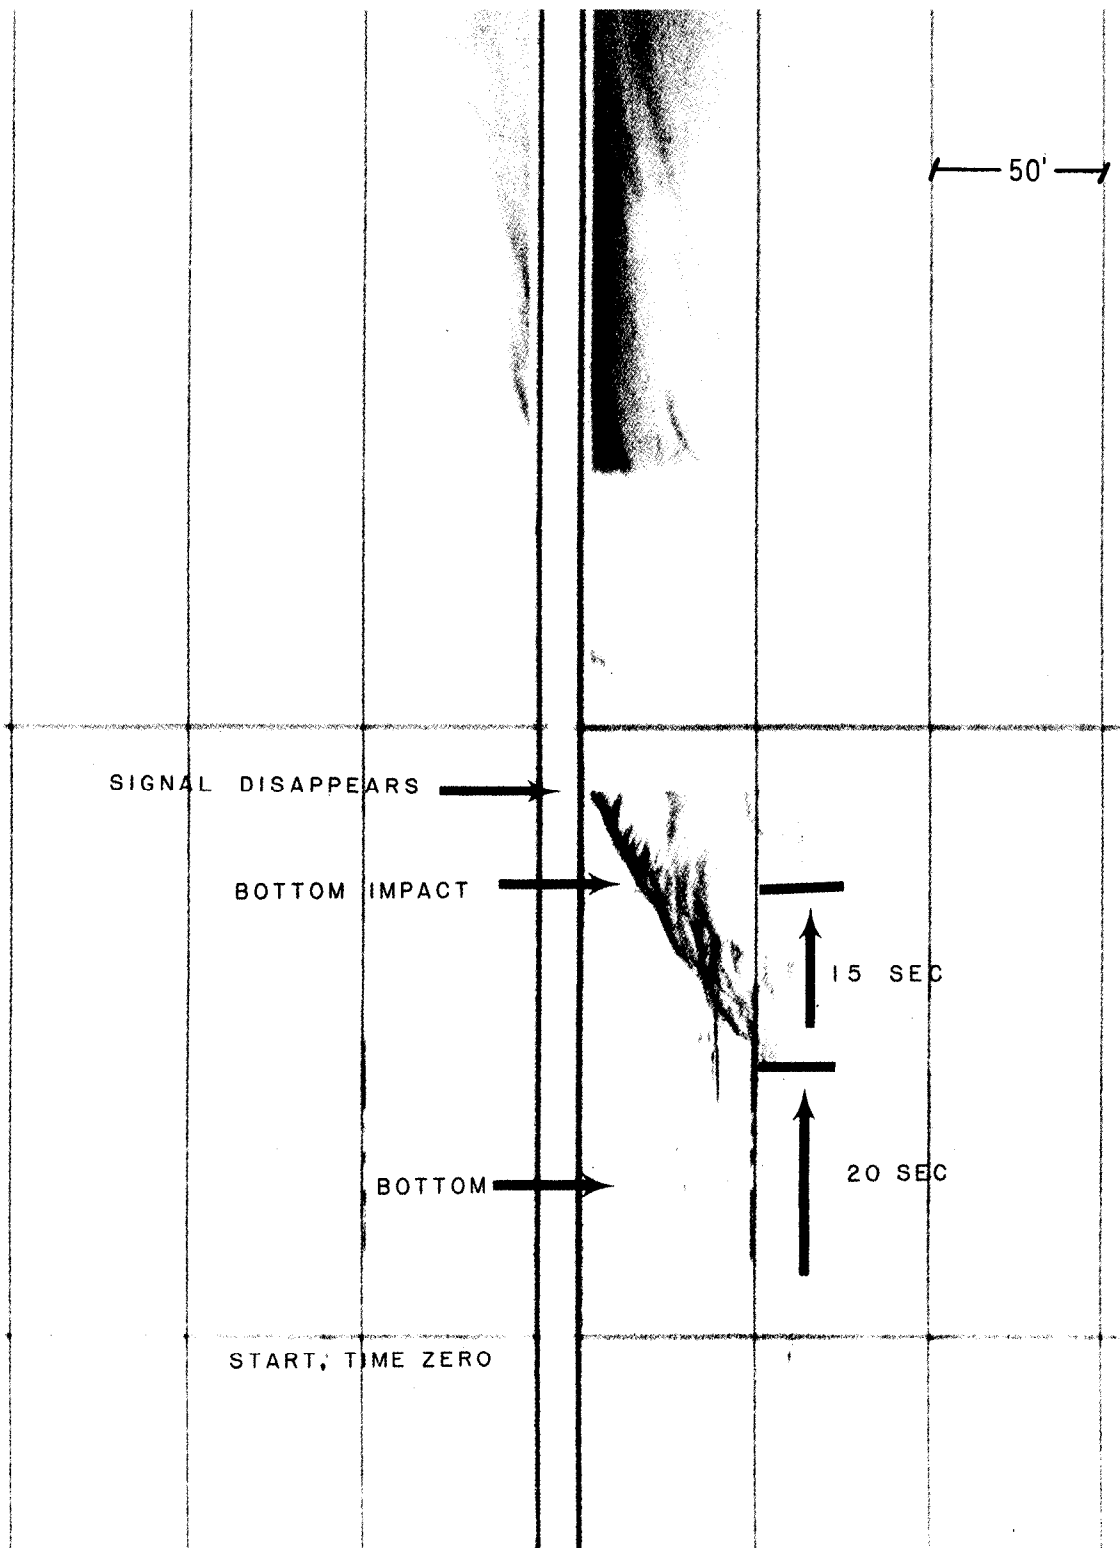
Figure 16. SSS image of contaminated sediment disposal

70. Fortunately, these settings proved to be correct, and the disposal was clearly visible on the record (Figure 16). According to the barge operators, the material did not completely exit the barge until 20 sec after the start of the disposal. This corresponds exactly with the SSS record (Figure 16). The material exited the barge at just over 20 sec and hit the bottom

15 sec later. Twenty-one seconds after the material left the barge, the image disappeared for 24 sec. It is possible that this disappearance was due to the mud wave covering the "fish." After the image returned at 65 sec from the start, there appeared to be a substantial amount of material in the water column on both sides of the "fish." At 2 min 2 sec after the start, the amount of sediment in the water column was greatly reduced but did not disappear. This could be the result of a change in orientation of the SSS "fish" due to barge maneuvering. However, the image was not smeared as it usually is during maneuvering. This water column sediment reduction lasted for 50 additional seconds. After that point, the sediment content of the water column increased to about its former level and remained there until approximately 10 min after the start. Past 10 min, maneuvering of the barge made good observations of the sediment level determination impossible up to the time the recorder was turned off at 15 min from the start of the disposal.

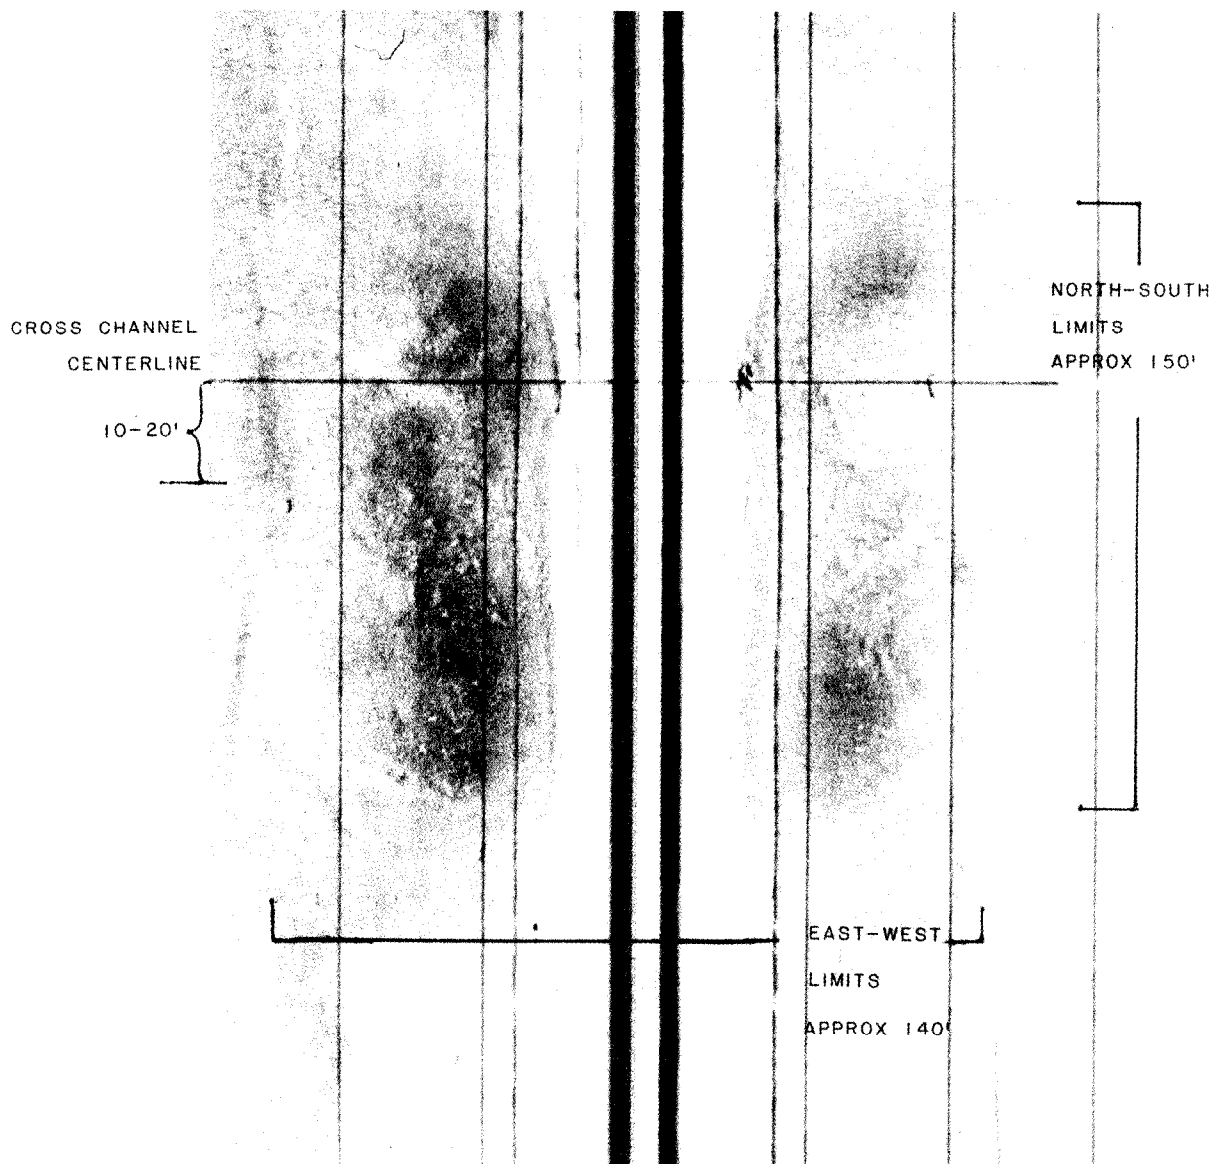
Figure 17. SSS image of the first sand cap

72. Using the 500-kHz "fish," an SSS inspection of the first sand cover was made on 29 March 1984. After several passes, both parallel and perpendicular to the channel, a fair estimate of the shape and extent of the sand cover could be made. The shape was basically rectangular (Figure 17) with slight indentations on the perpendicular axis. It appeared that the cover extended 65 ft north and 90 ft south of the cross channel center line and 70 ft on either side of the channel center line. However, the dark event line on the figure representing the center line of the hole is displaced by an estimated 10 to 20 ft to the north. It appears to be on the top of the edge of the depression instead of in the center. After the event line is moved back to the center of the hole, the revised estimate for the sand cover dimensions is 75 ft north and 75 ft south of the center line. These dimensions correspond well to the contours produced from the hydrographic surveys shown in Figure 6.

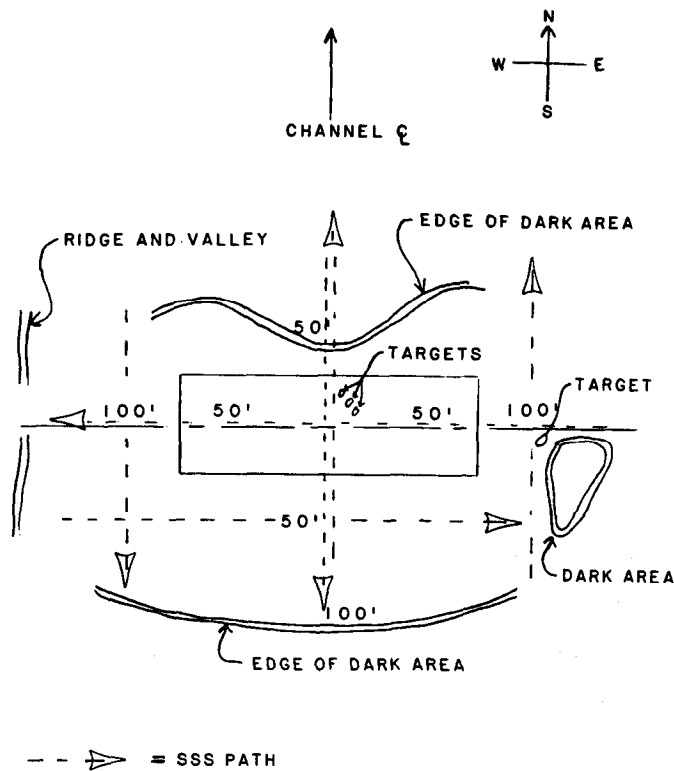
Figure 18. Completed sand cap coverage

73. On 2 April 1984, the 500-kHz "fish" was used to inspect the completed sand cap. A total of ten passes was made over the drop site. An attempt was also made to determine the thickness of the sand cap using the subbottom profiler. The sound pollution created by using the SSS and subbottom profiler simultaneously seriously degraded the topographic features and sediment texture differences on the record while producing a poor estimate of the cap thickness.

74. Although the quality of the records was too low for good reproduction, it was possible to make an estimate of the extent of the sand cap. In Figure 18, the outline of the depression is shown along with the tracks of the six best SSS passes. On the figure are four features which show the estimated boundaries of the sand cap. A north-south running ridge and a valley are seen at the western edge of the channel. Dark areas, presumed to be areas covered by sand, are seen to the north, south, and east. Several targets are also illustrated. They aided in determining location of the features. The northern boundary is 35 to 65 ft north of the long axis of the depression, and the southern boundary is approximately 100 ft south of the axis. The eastern and western boundaries are 140 and 150 ft, respectively, from the center line of the channel. It appears that the original depression was completely covered by the sand cap.

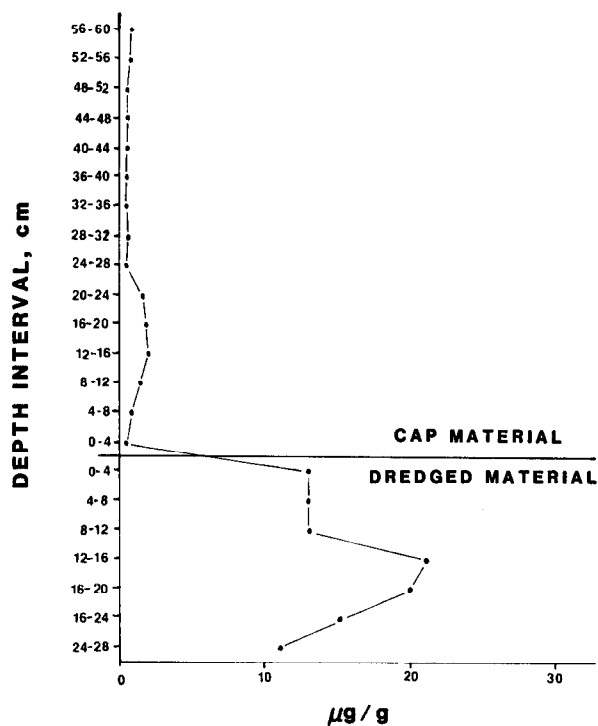
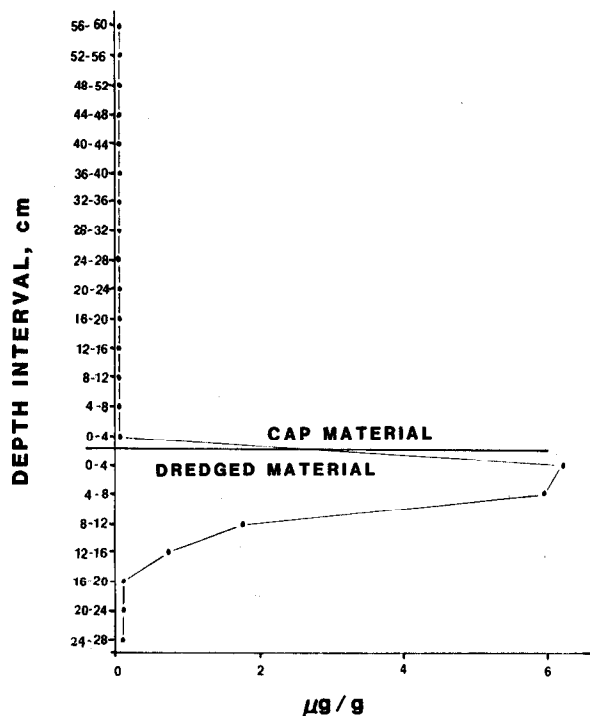
LEAD

AROCHLOR 1242

Figure 19. Chemical profile through the cap

82. Results of chemical analysis of initial core samples indicated that the dredged and cap materials formed a sharp, relatively unmixed interface. This is illustrated in Figure 19, which presents Pb and Arochlor 1242 PCB concentrations in a core at the Duwamish capping site. Both Pb and PCBs were initially either absent or present in low concentrations in the cap materials. Below the cap/dredged material interface, however, high concentrations of Pb and PCB relative to those in the cap material were noted.

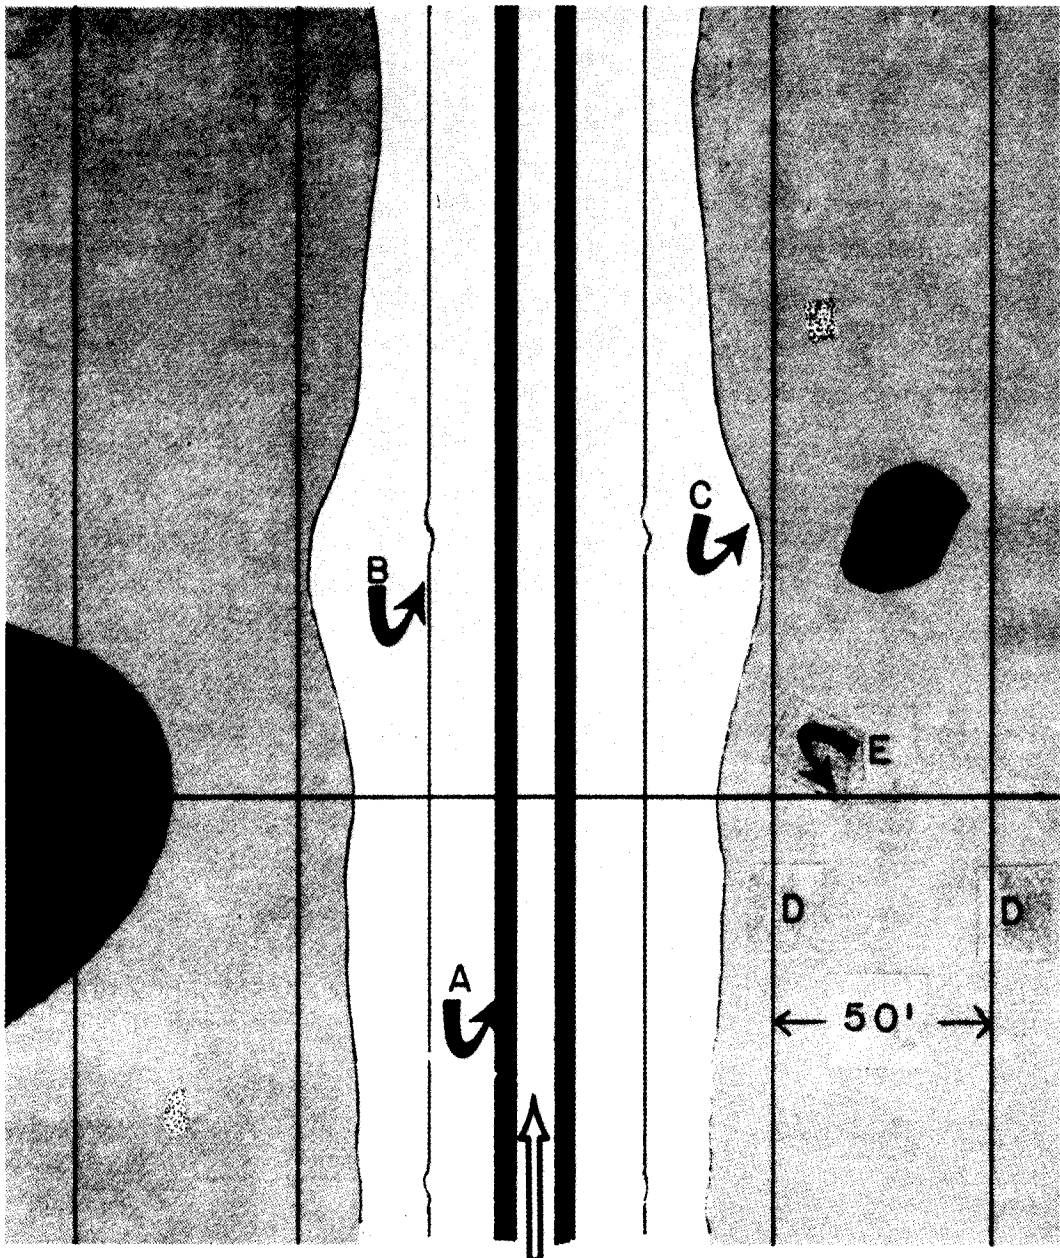
DIRECTION OF FISH MOVEMENT

Figure B1. Example SSS record

6. The following discussion applies to Figure B1. The dark parallel lines (A) running down the center of the sonograph are the starting points of
